Aviation Maintenance Alerts

AC No. 43-16A

**ALERT NO. 241
AUGUST 1998**

**Improve Reliability-
Interchange Service
Experience**

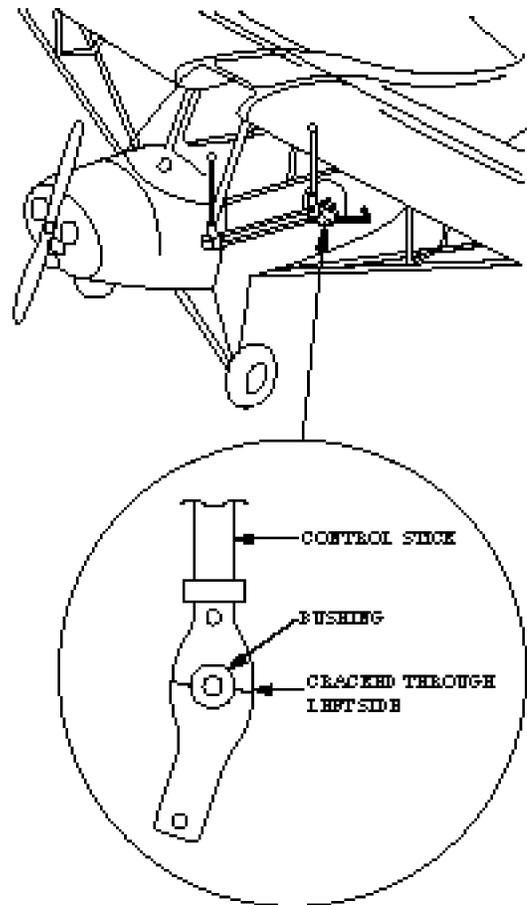
**Aeronca; Model 8BCM (Converted 7AC);
Champ; Cracked Control Stick Socket;
ATA 2701**

During the annual inspection, the technician discovered a visible horizontal crack on the left side of the aft control stick socket assembly (P/N 2-207). This area was given extra attention because the pilot reported excessive play in the aileron control.

The crack went through the casting in the bearing boss area. Also, there was a hairline crack on the right side of the aft control stick socket assembly and on the forward stick socket assembly. The submitter stated the metal casting was thinner in the bearing boss area. (Refer to the following illustration.)

The submitter suggested that the manufacturer make the metal casting thicker in the bearing boss area. This area deserves your attention during inspections.

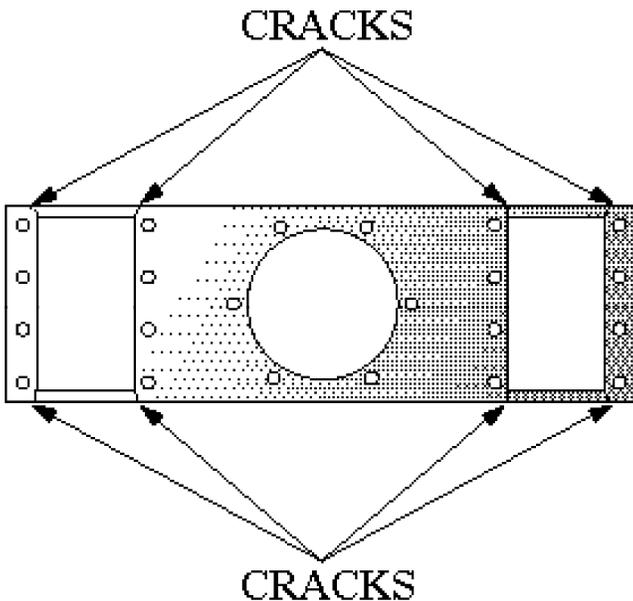
Beech; Model 23; Musketeer; Cracks in Stabilator Main Spar; ATA 5511

This aircraft is used for flight training. During an inspection, maintenance personnel found cracks in the stabilator main spar adjacent to the fuselage hinge attach point. (See the following illustration.)

This area deserves your attention during inspections.

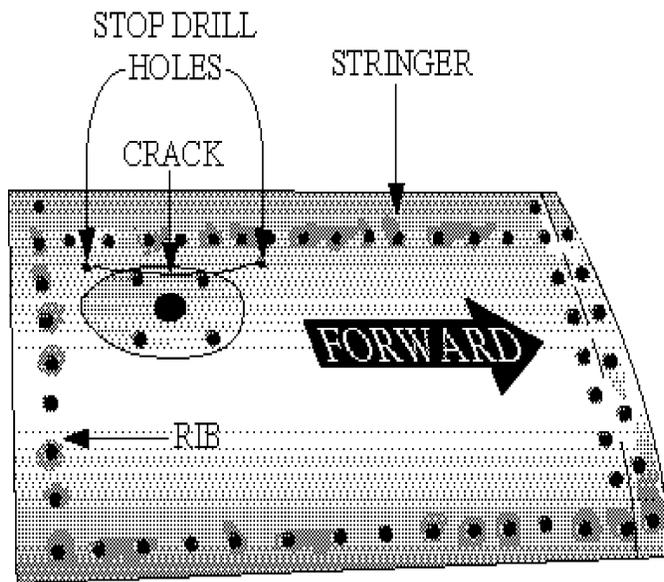
Beech; Model 60; Duke; Fuselage Structure Crack; ATA 5330

While installing avionics equipment, a crack was discovered on the upper fuselage skin.

The Long Range Navigation (LORAN) receiver was being removed and replaced with a Global Positioning System (GPS). When the LORAN antenna was removed from the top of the fuselage at fuselage station (FS) 200, a crack, approximately 4.25 inches long running parallel to the fuselage, was discovered. (Refer to the following illustration.) It appeared that the crack originated under the antenna base and migrated in both a forward and aft direction. Improper installation of the LORAN antenna was thought to have caused this defect. The antenna was installed using only a backing plate approximately the same size as the antenna base, with no doubler inside.

The aircraft manufacturer conducted complex, time consuming, and costly repair procedures on this area. This is a pressurized aircraft, and defects in the pressure vessel will endanger the occupants and the aircraft. Any equipment, especially antennas attached to the fuselage, should be inspected for proper installation and condition during scheduled inspections.

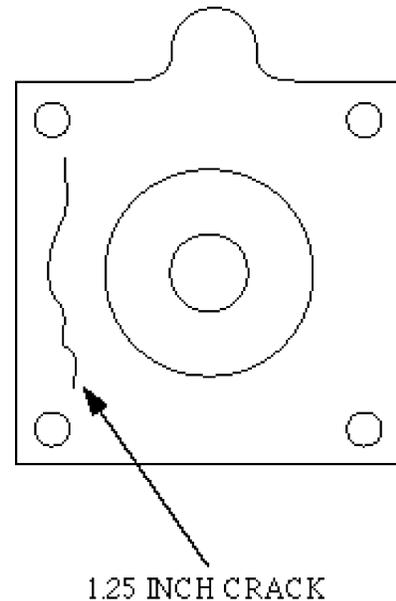
Beech; Model 65-B80; Queen Air; Cracked Air Pump Adapter; ATA 8300

Maintenance personnel performed a dye-penetrant inspection on the air pump adapter (P/N LW12540). From experience, the technician knew that cracks can develop in the area of the flange attach point holes. As the technician suspected, the inspection revealed a crack in the area of the flange which attaches the part to the engine accessory case. (Refer to the following illustration.)

The submitter has a fleet of seventeen similar model aircraft. This defect is common in a fleet of this size, with at least eight occurrences a year.

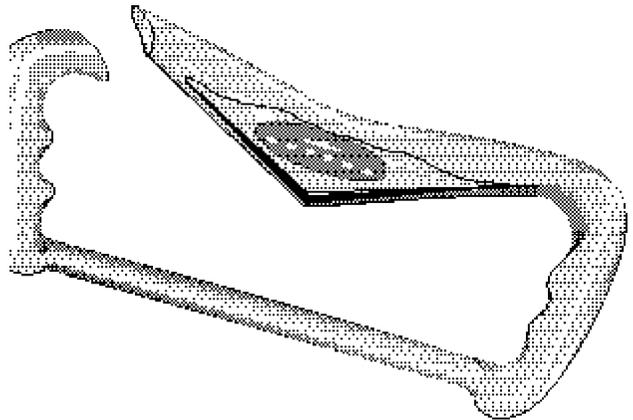
Cessna; Model 182F; Skylane; Control Yoke Failure; ATA 2701

The control yoke failed at the upper left corner. (Refer to the following illustration.) The control yoke was installed as original equipment in 1963. Over the years, the effects of sunlight and temperature caused the plastic material to deteriorate. The first signs of deterioration may be a dull appearance, small

spider web surface cracks (crazing), and/or chips, dents, nicks, or surface exfoliation.

The control yoke(s) should be inspected for these conditions at every opportunity.

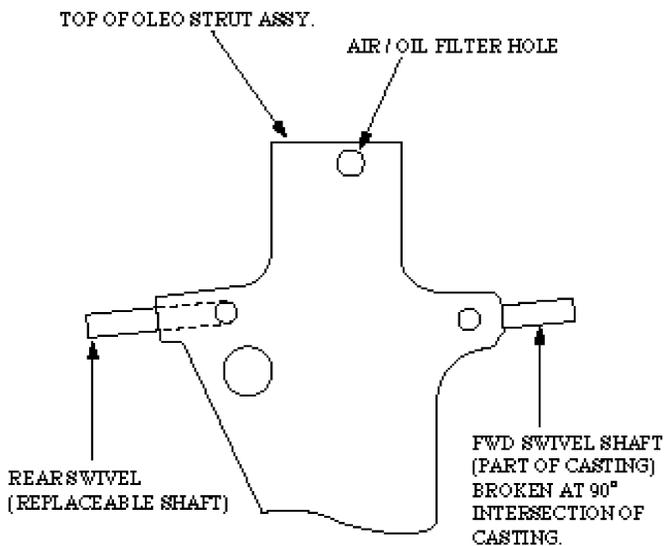
Piper; Model PA-28-R200; Arrow; Broken Landing Gear Pivot; ATA 3213

While lubricating the main landing gear, the technician discovered a broken swivel shaft on the left main gear.

The forward swivel shaft was broken at a 90-degree angle where it entered the oleo strut housing (P/N 67035). (Refer to the following illustration.)

The cause of this defect was believed to be hard landings and/or a concentration of stress at the junction of the swivel shaft and the strut housing. Failure to find this problem could have resulted in a landing accident.

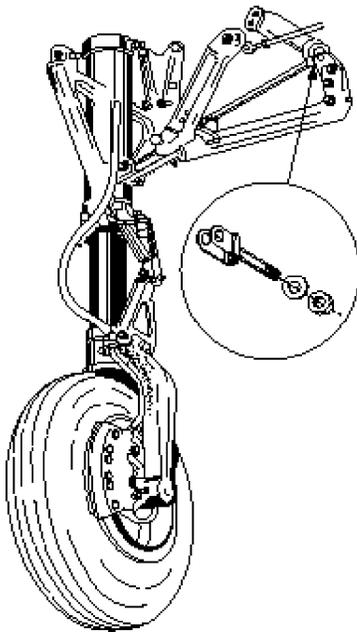
Piper; Model PA-31-350; Chieftain; Landing Gear Retraction Failure; ATA 3230

An inspection disclosed a broken left main gear lock rod attachment fork (P/N 41789-00). The rod attachment fork broke at approximately the midpoint of the shank. (Refer to the following illustration.)

This defect was also found on one other like aircraft from this fleet. Maintenance personnel should inspect the rod attachment fork for general condition and for a bent or broken shank at every opportunity. A 1,000-hour inspection interval was suggested.
